**Subsidence Documentation Study**  
**Sufco Mine**  
**May 30, 2003**  
**Summary**

The data contained in this binder is a compilation of subsidence features gathered in the field from the 19 of May to the 22 of May 2003. The features have been organized into five different sections representing panels in descending order starting with the most recent. At the beginning of each section is a summary sheet outlining important aspects of the panel with emphasis on subsidence features contained therein.

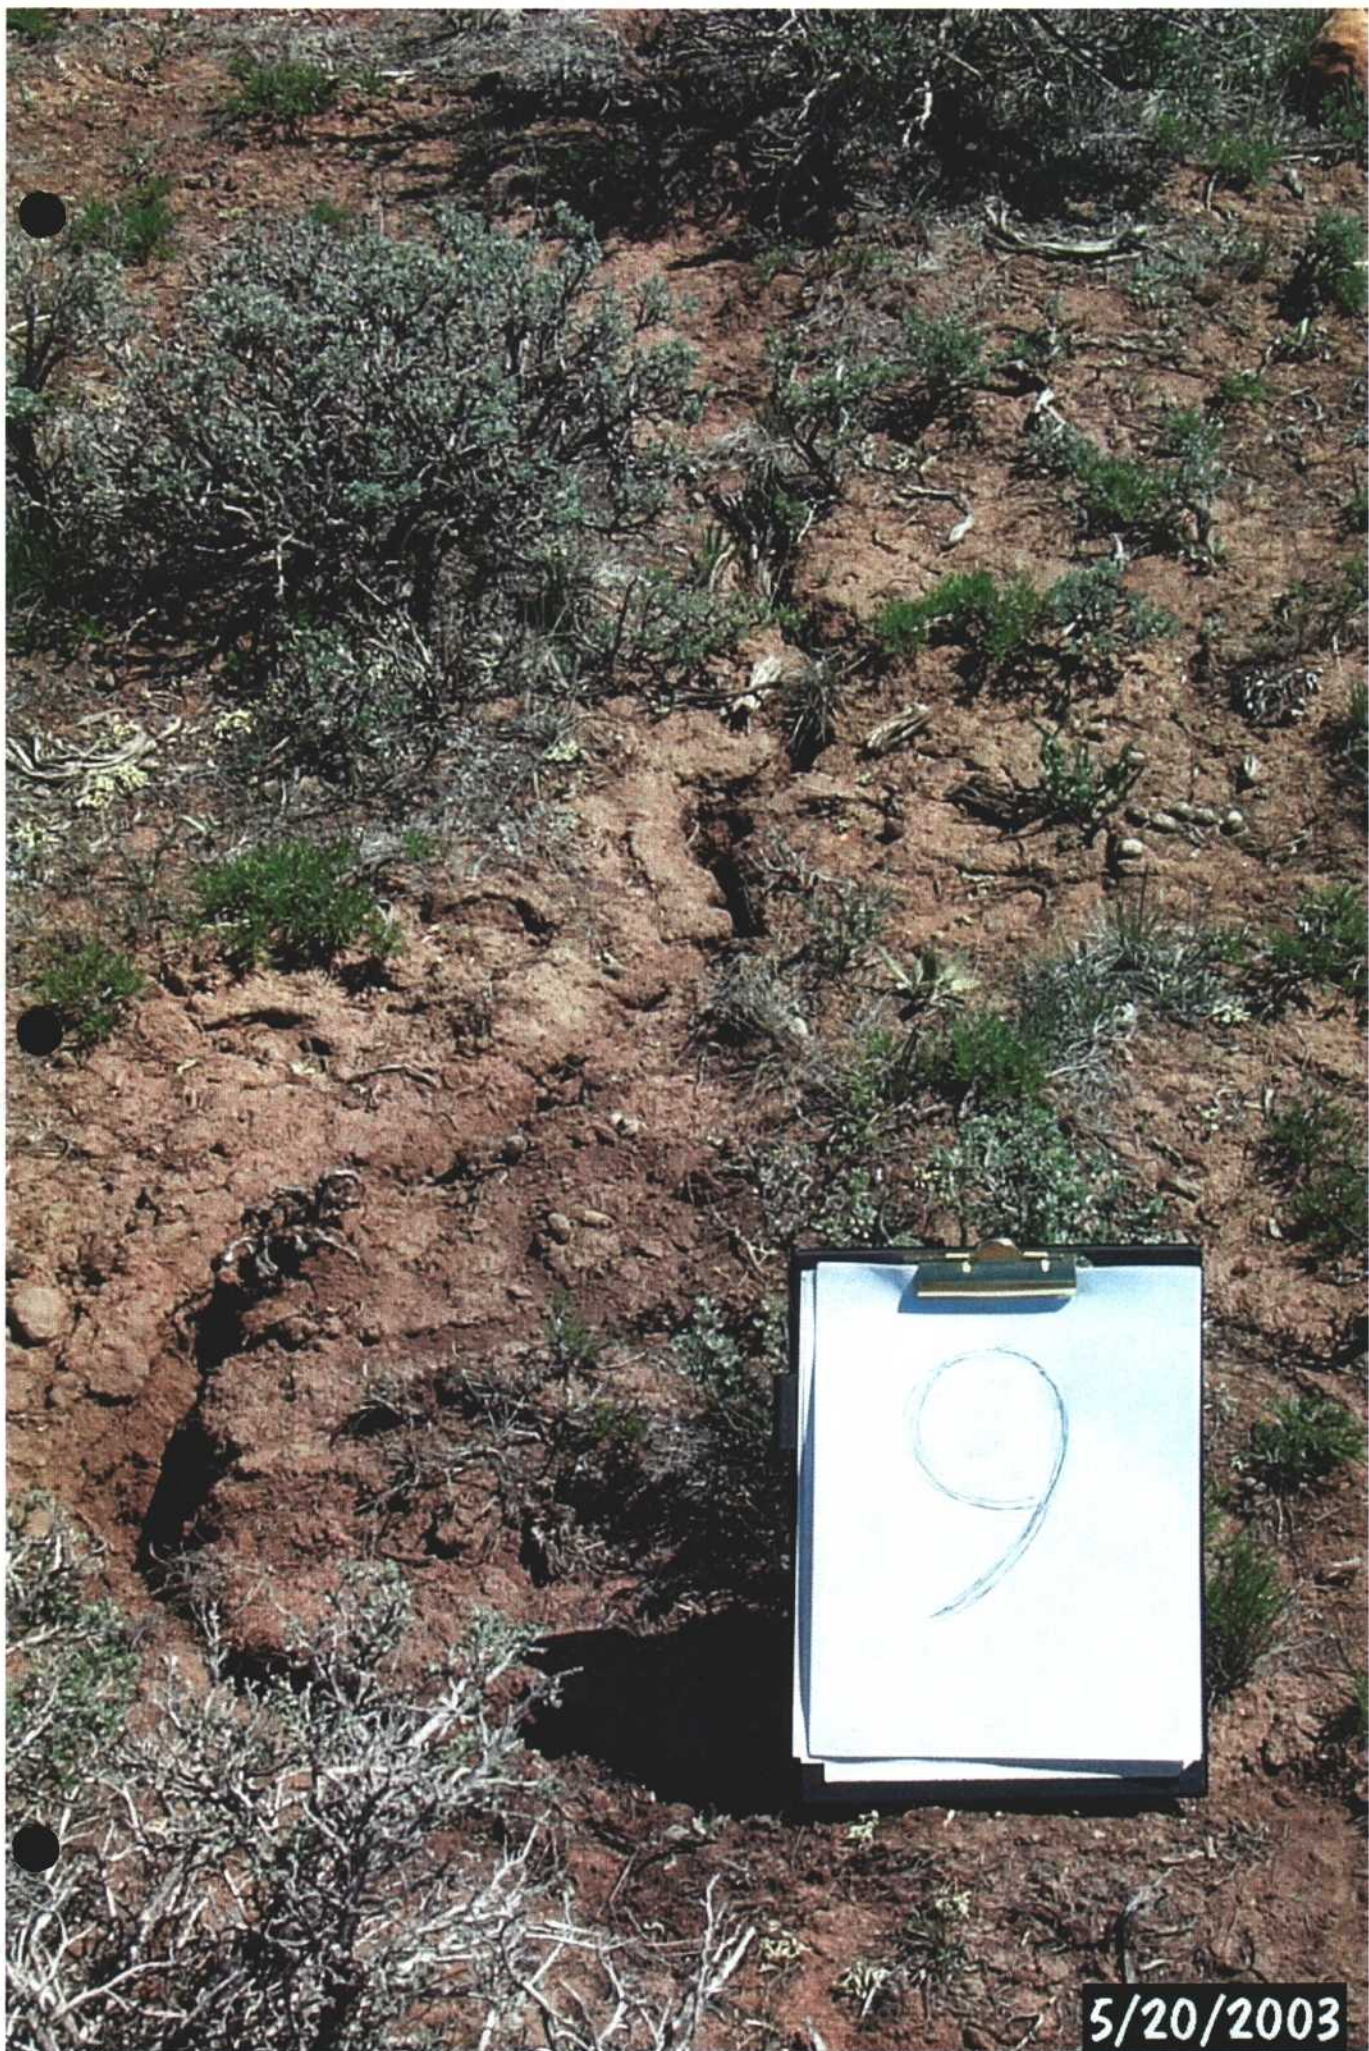
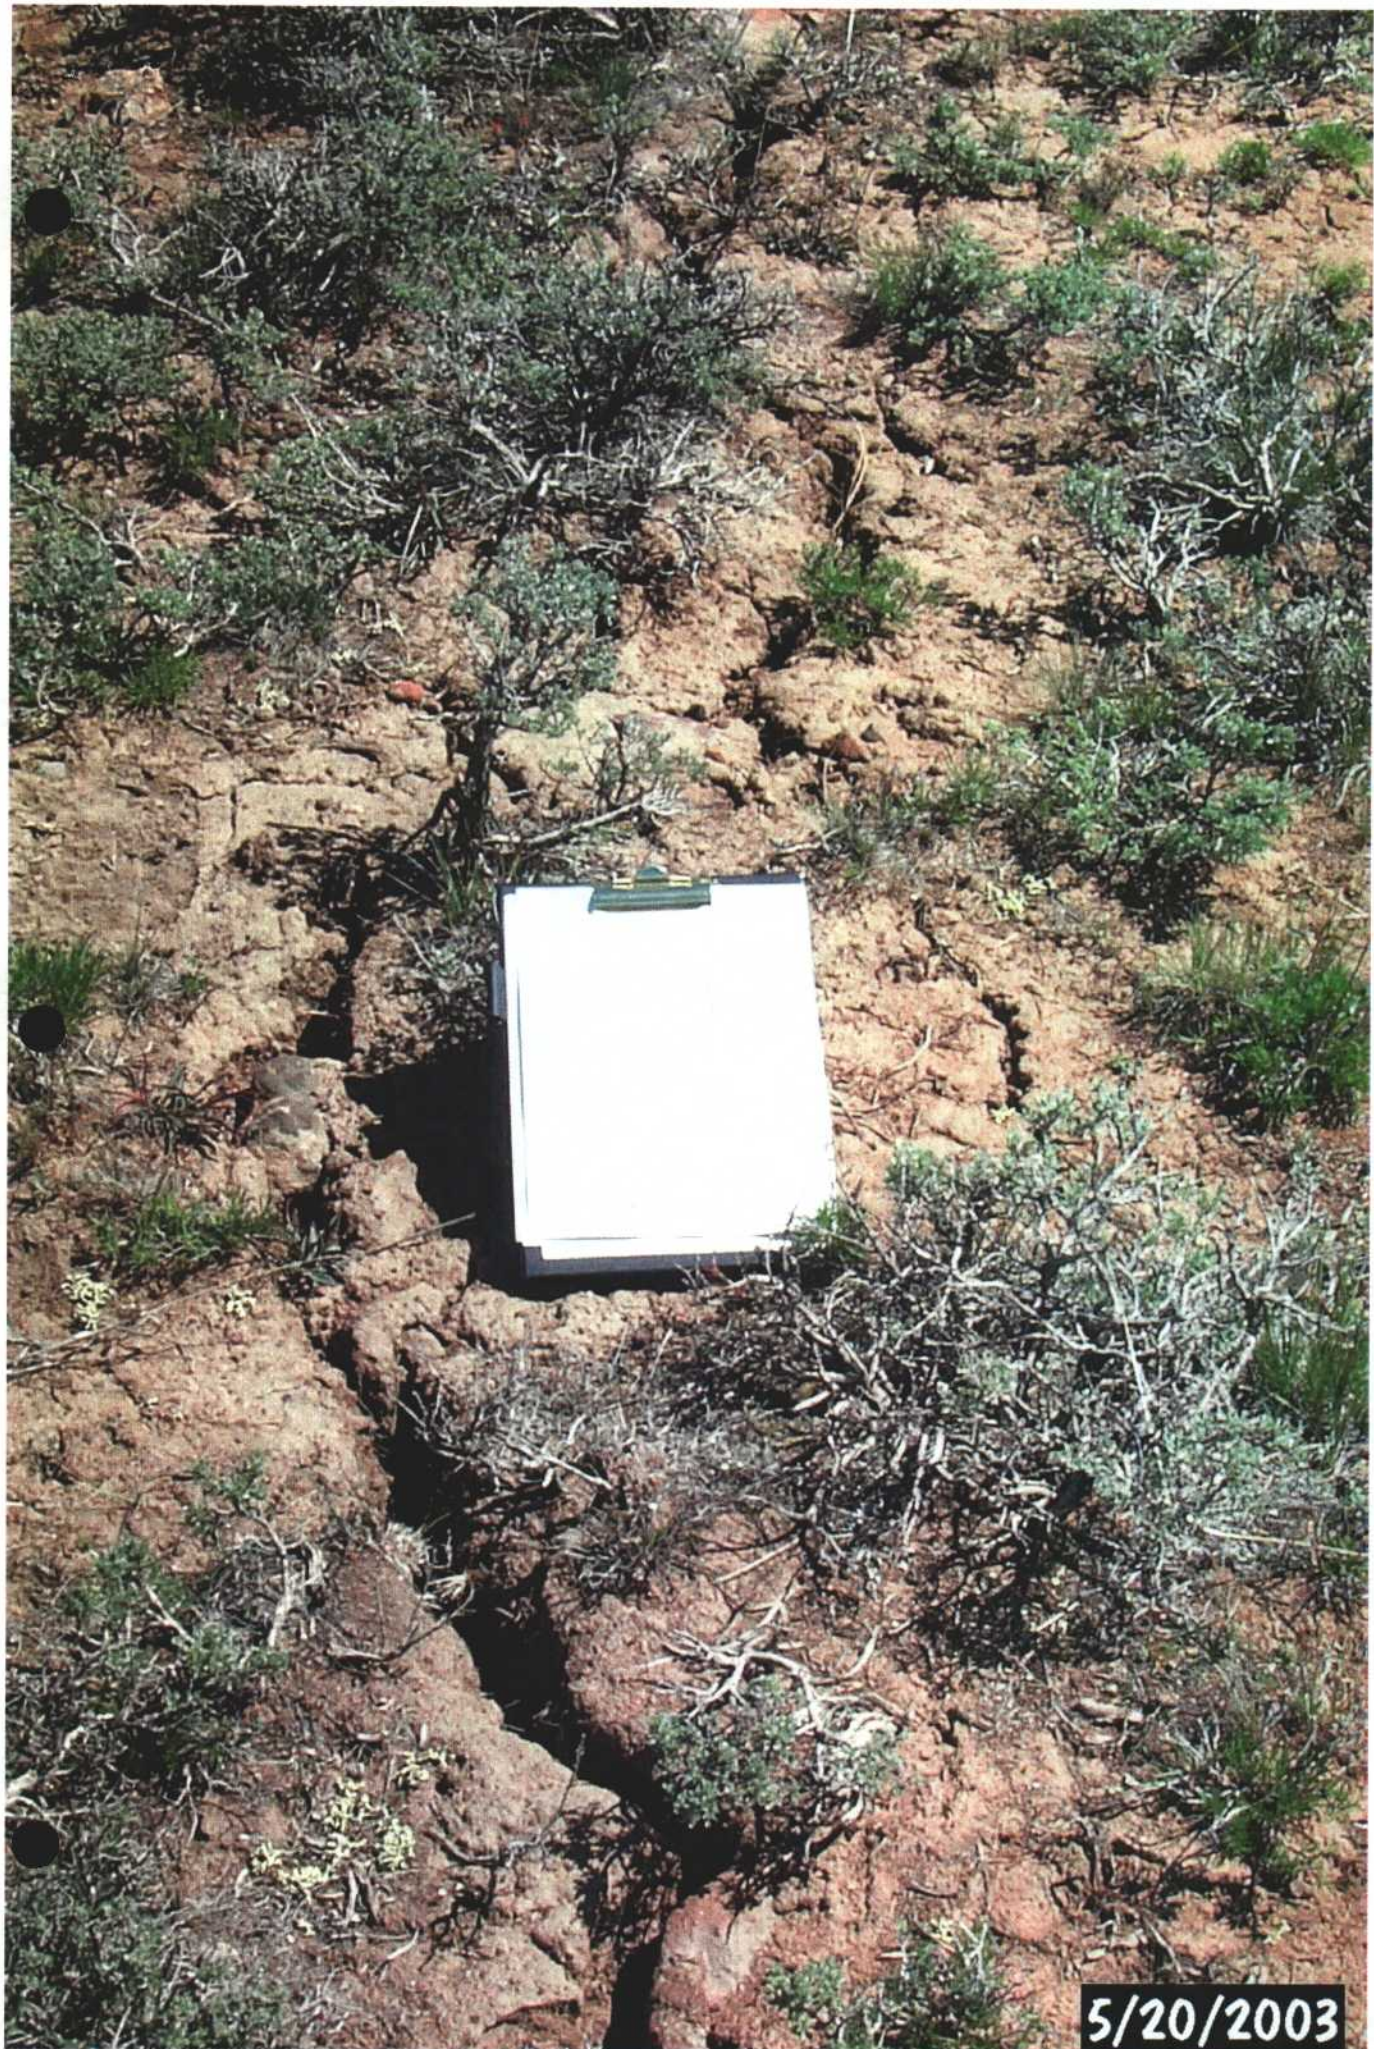
**Panel:** 1 left pines east **Feature #** 8

**Dimensions (in feet):** This crack is 225 feet long and up to 6 inches wide. Depth varies from a few inches to over a foot.

This crack is similar to feature #7 however appears to be healing along entire length.

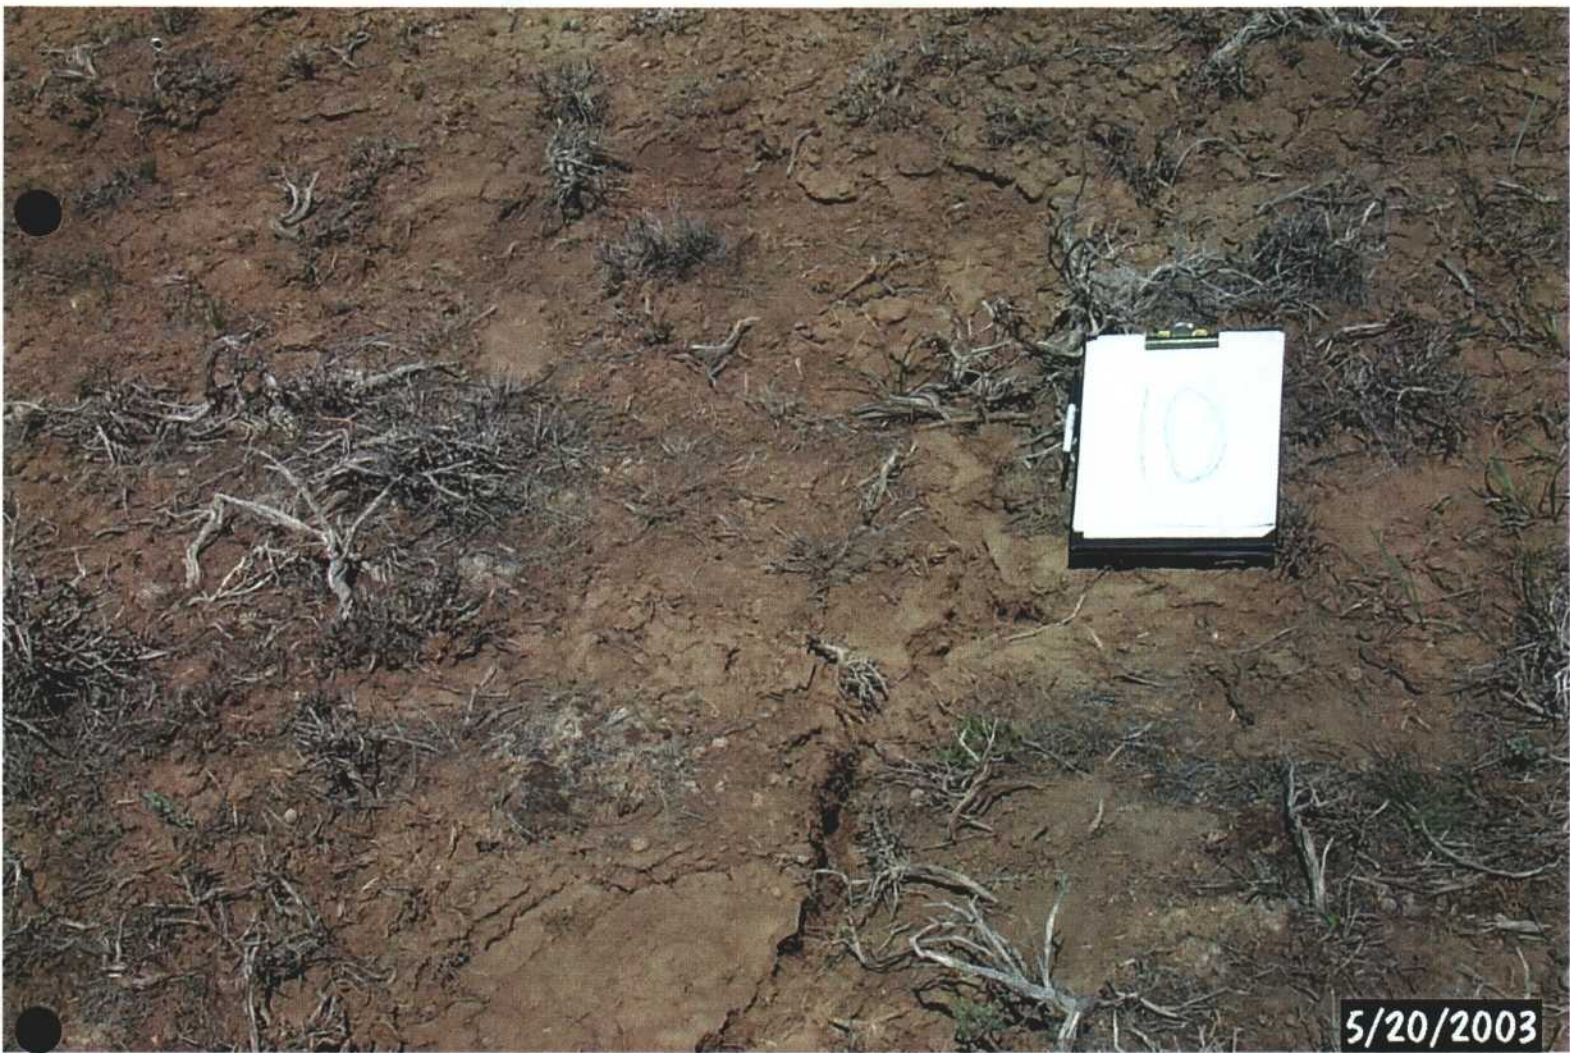
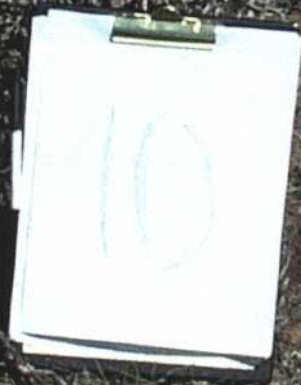
**Dimensions (in feet):** This crack is approximately 300 feet long. Depth and width varies between 2 and 8 inches.

This feature is actually a series of cracks running end-to-end, which gives the impression that this used to be one continuous crack at one point. The healing process has closed this crack off in many places.

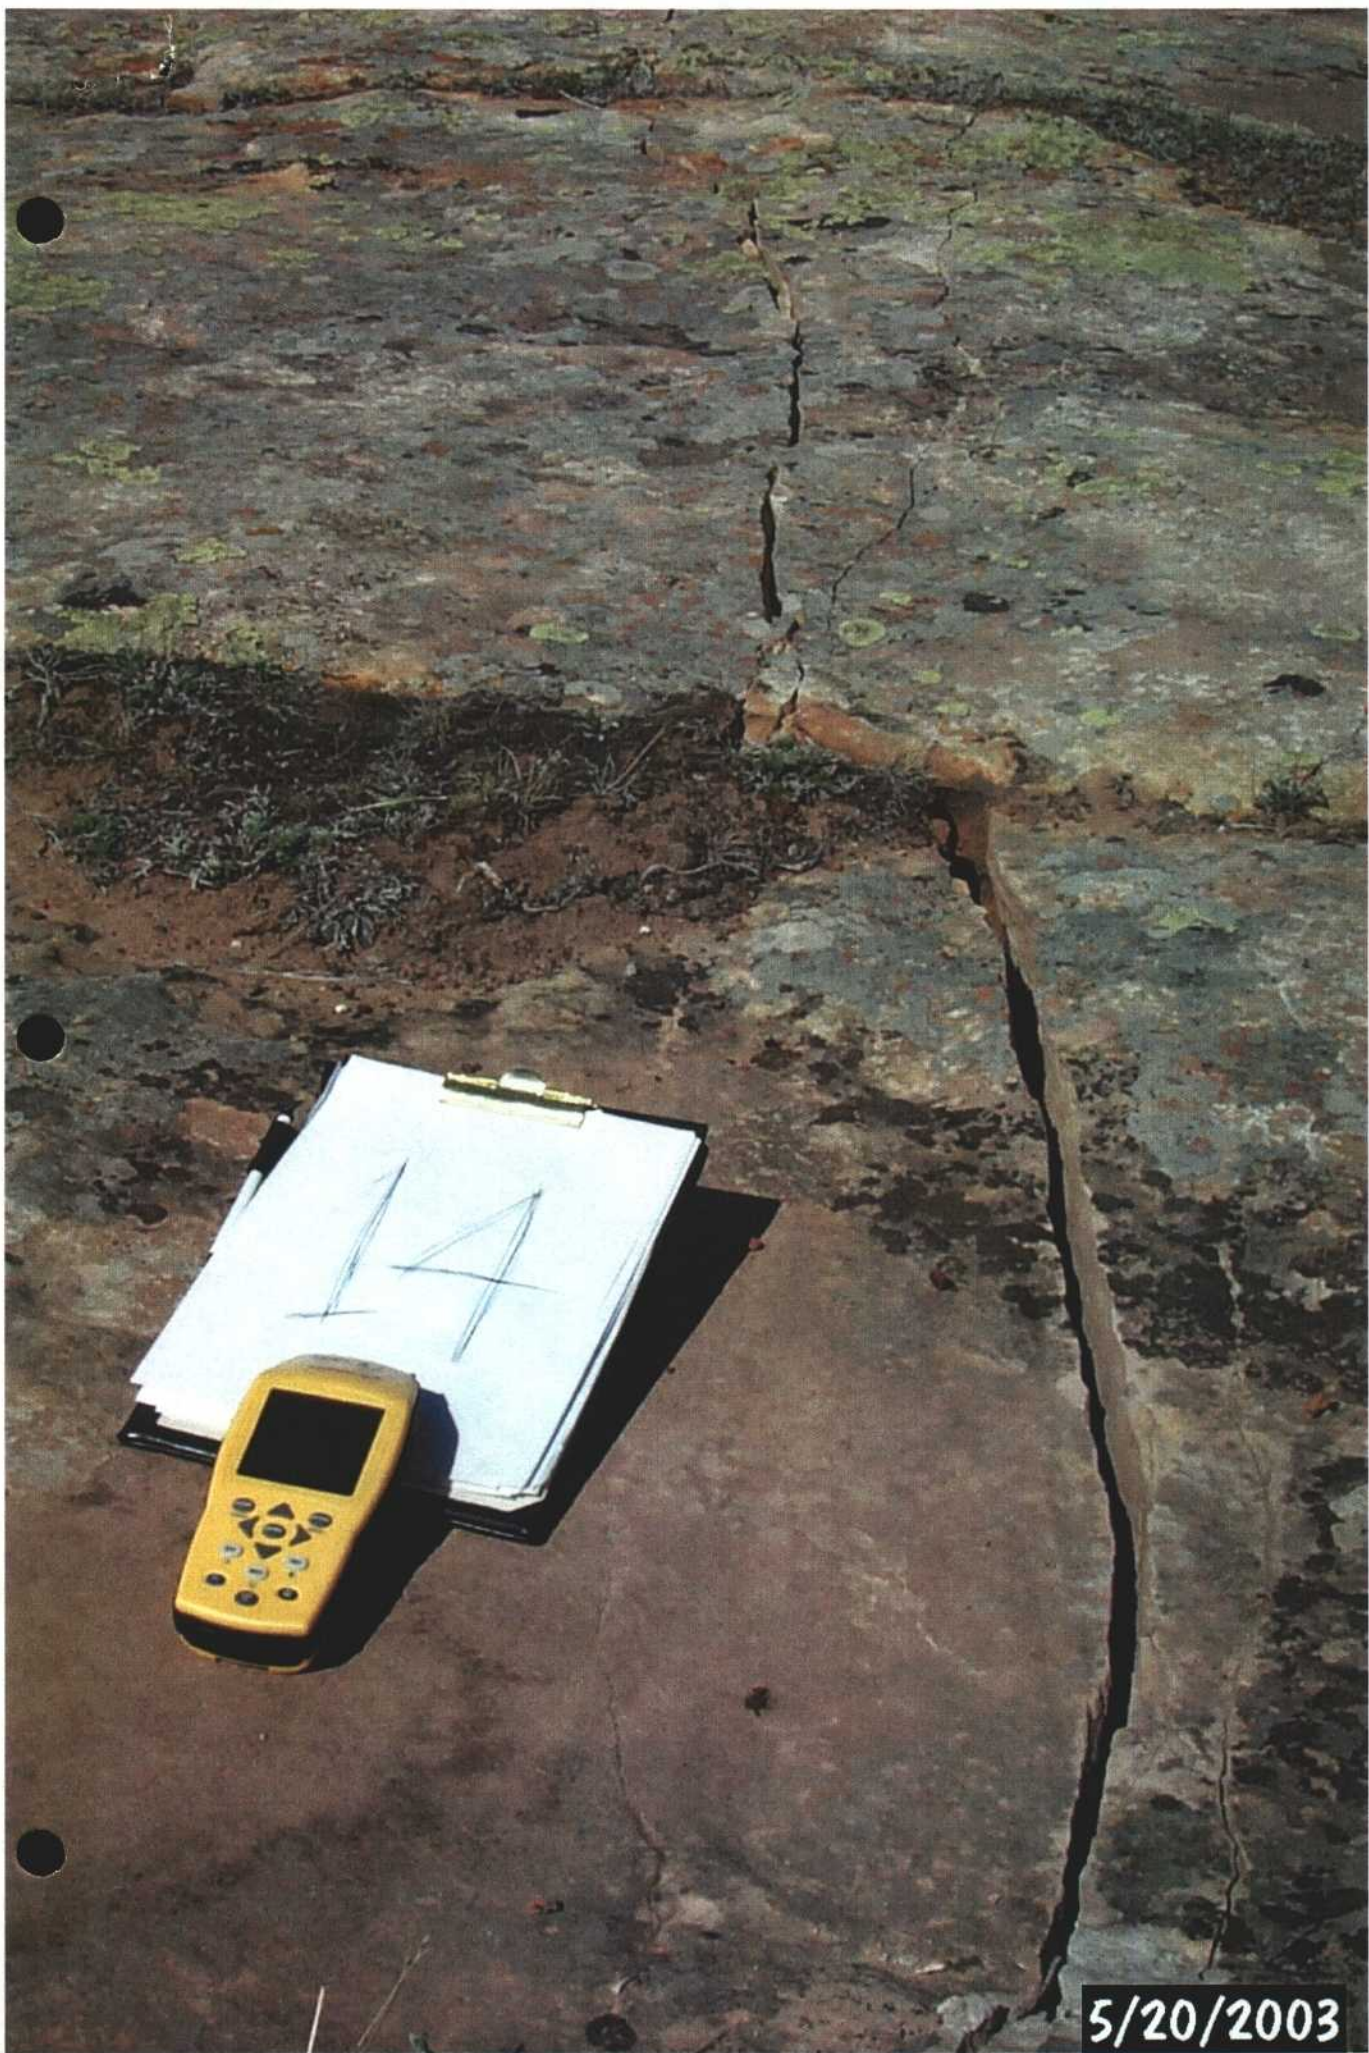
**Dimensions (in feet):** This crack is 101 feet long, and up to 1 inch wide.

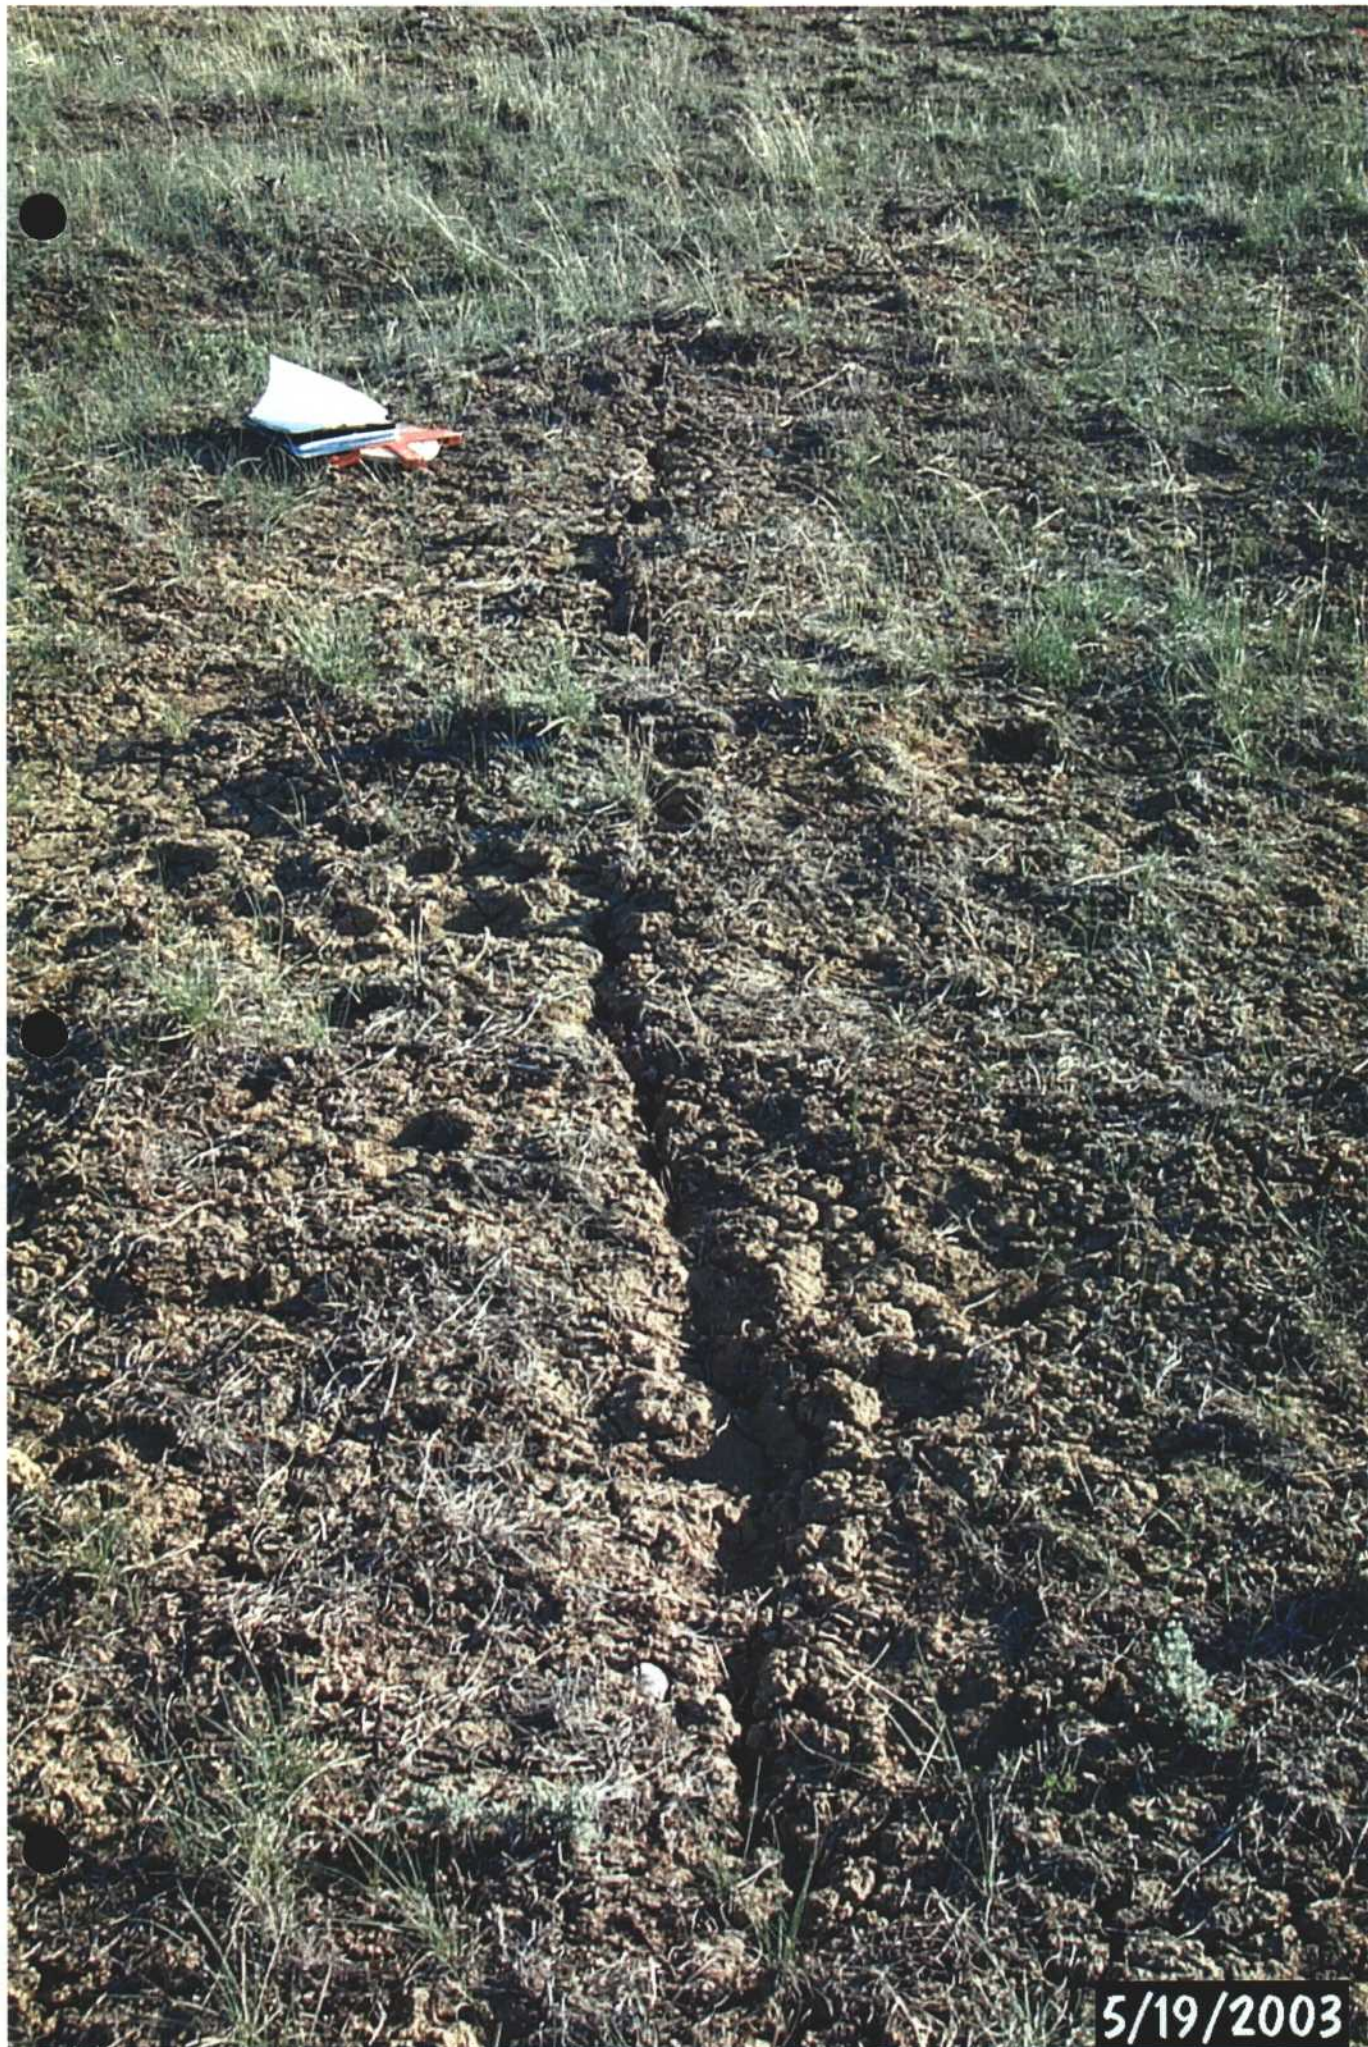
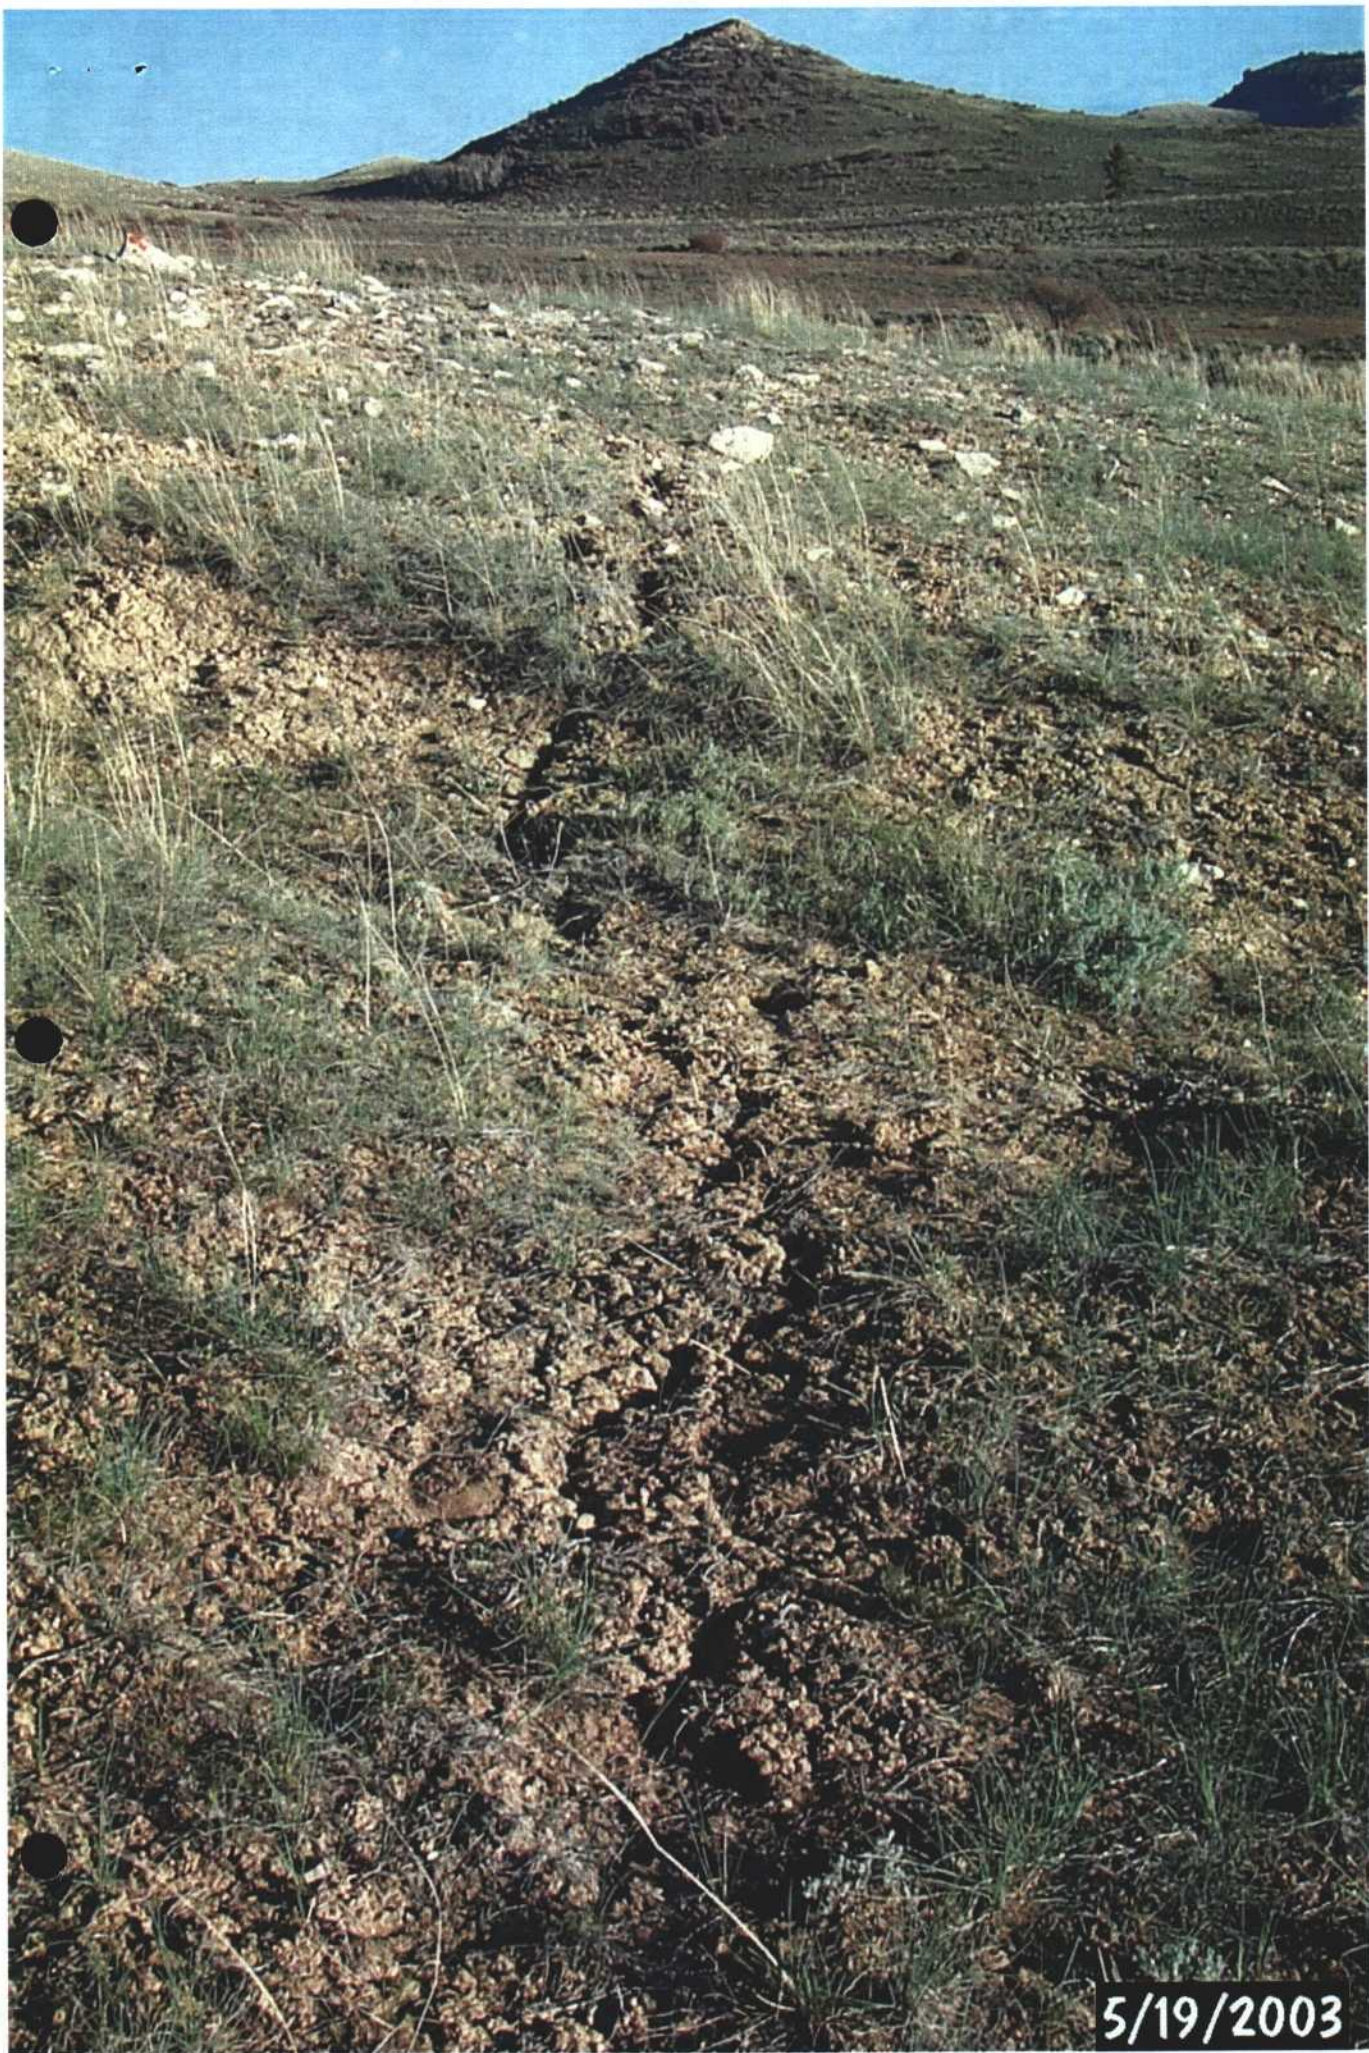
**Dimensions (in feet):** This is a series of three cracks all averaging 20 feet in length.  
Average depth is about 3 inches, and average width is also 3 inches.

These cracks are healing, and are almost completely filled in.

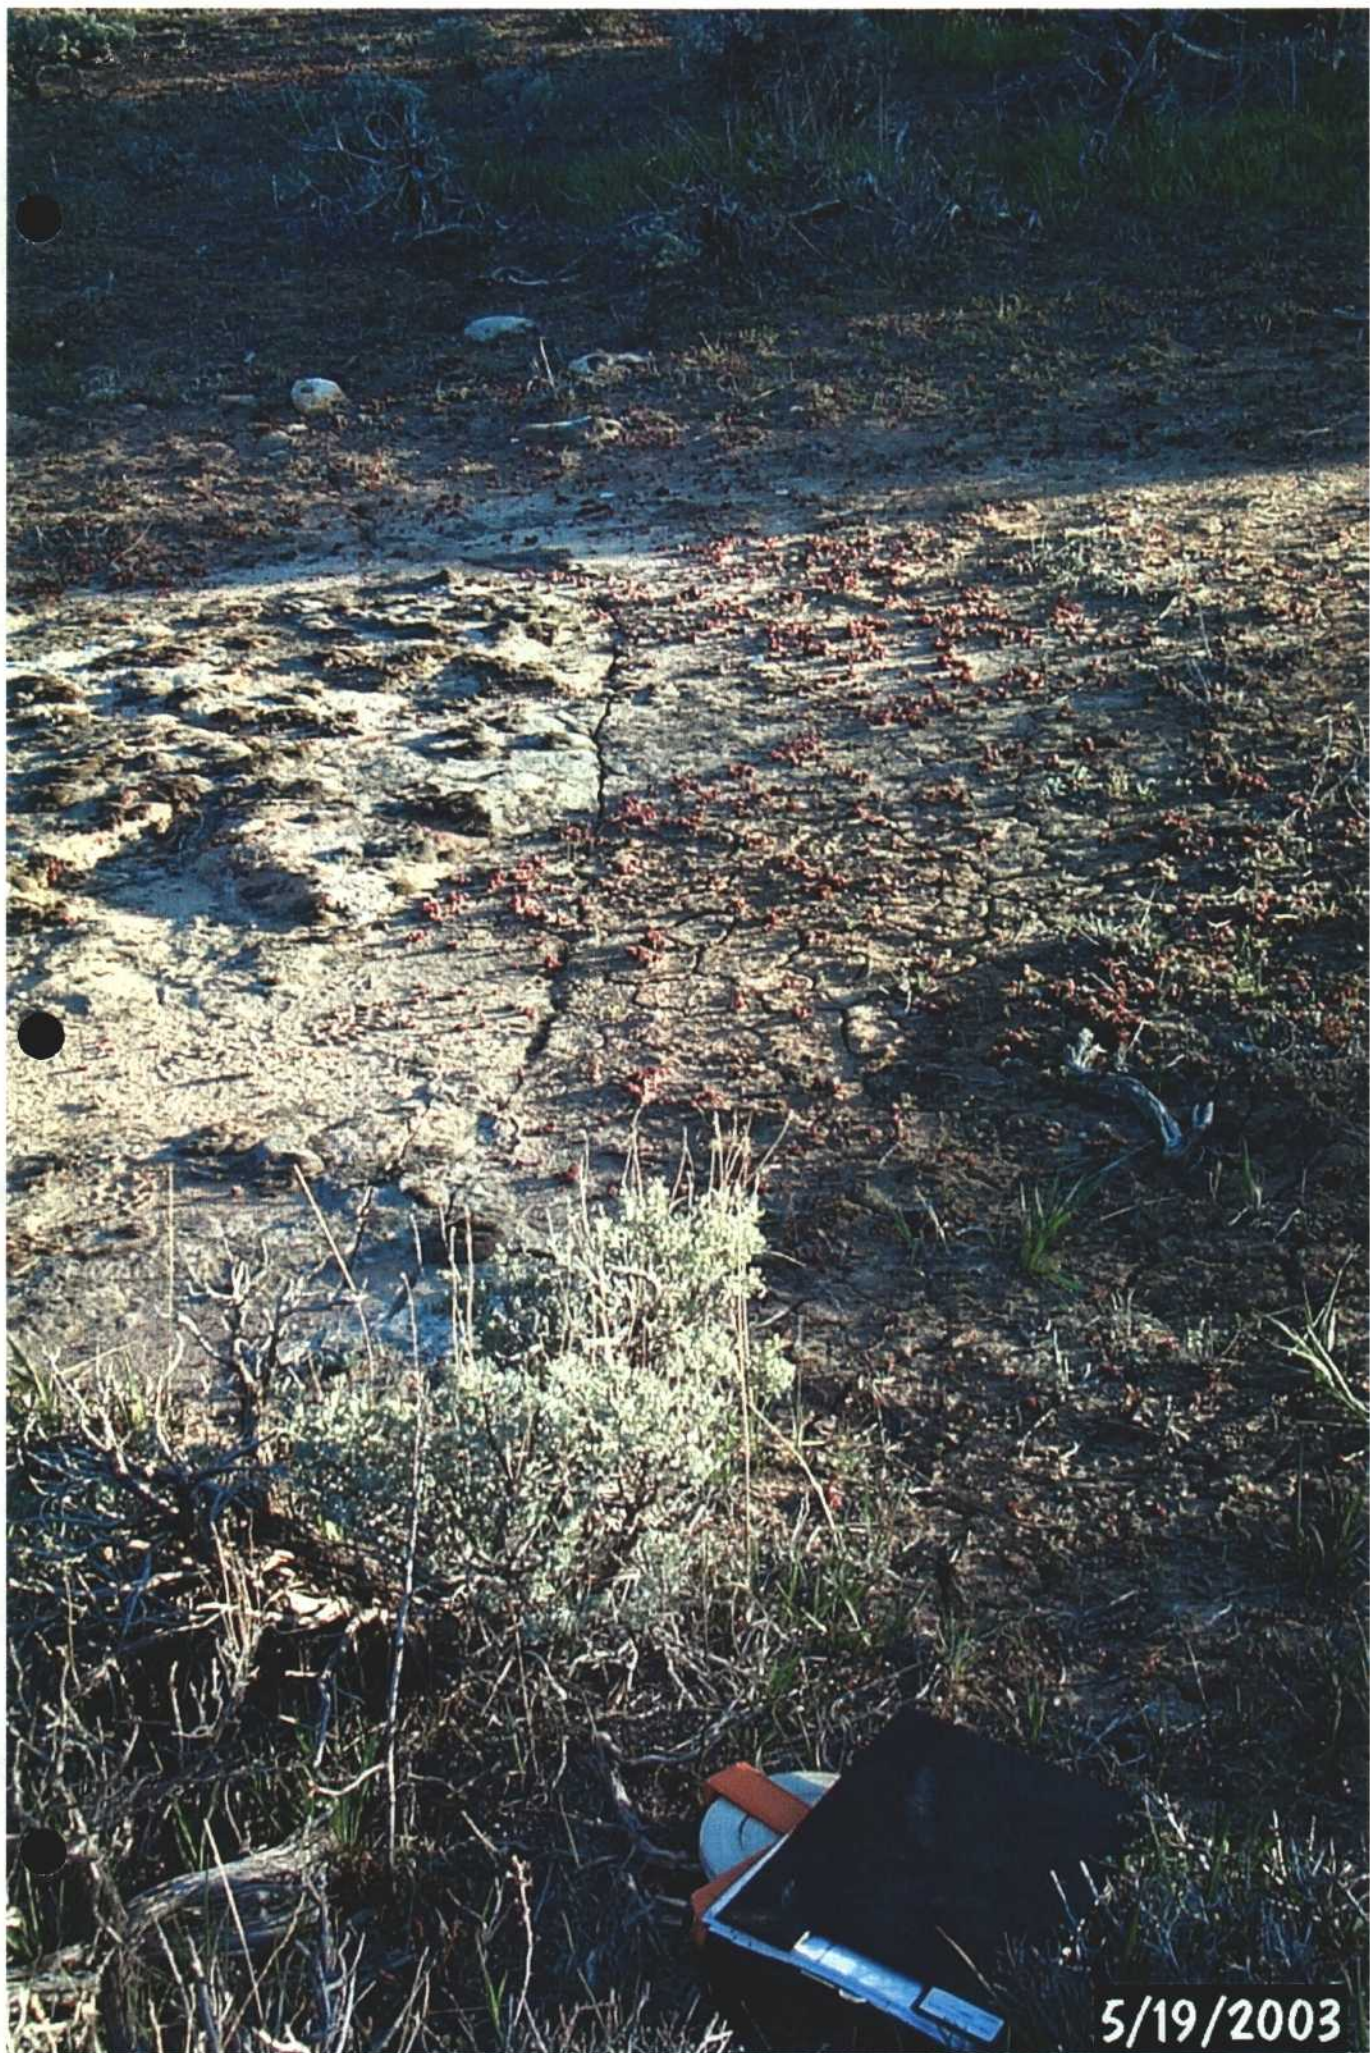
**Dimensions (in feet):** This crack is 18 feet long and approximately one inch wide.
